3.0 Sherwood

Sherwood Site Long-Term Custody Compliance Requirements

Sherwood Site Inspection Results

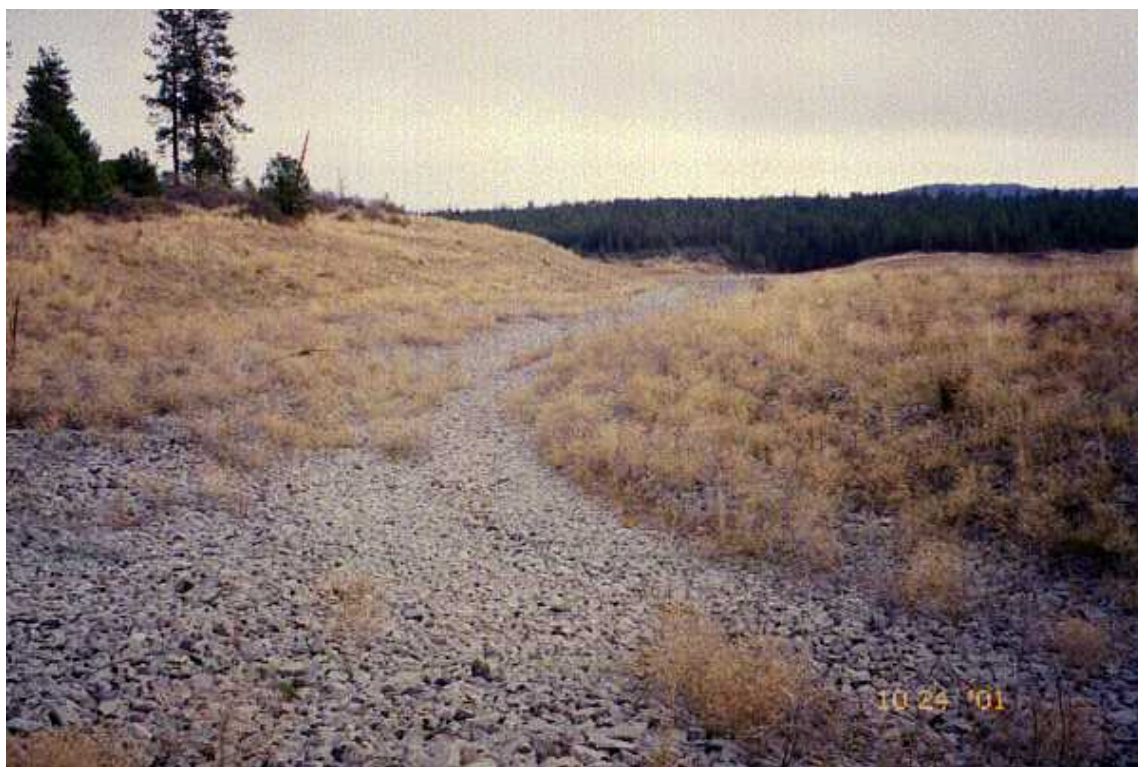
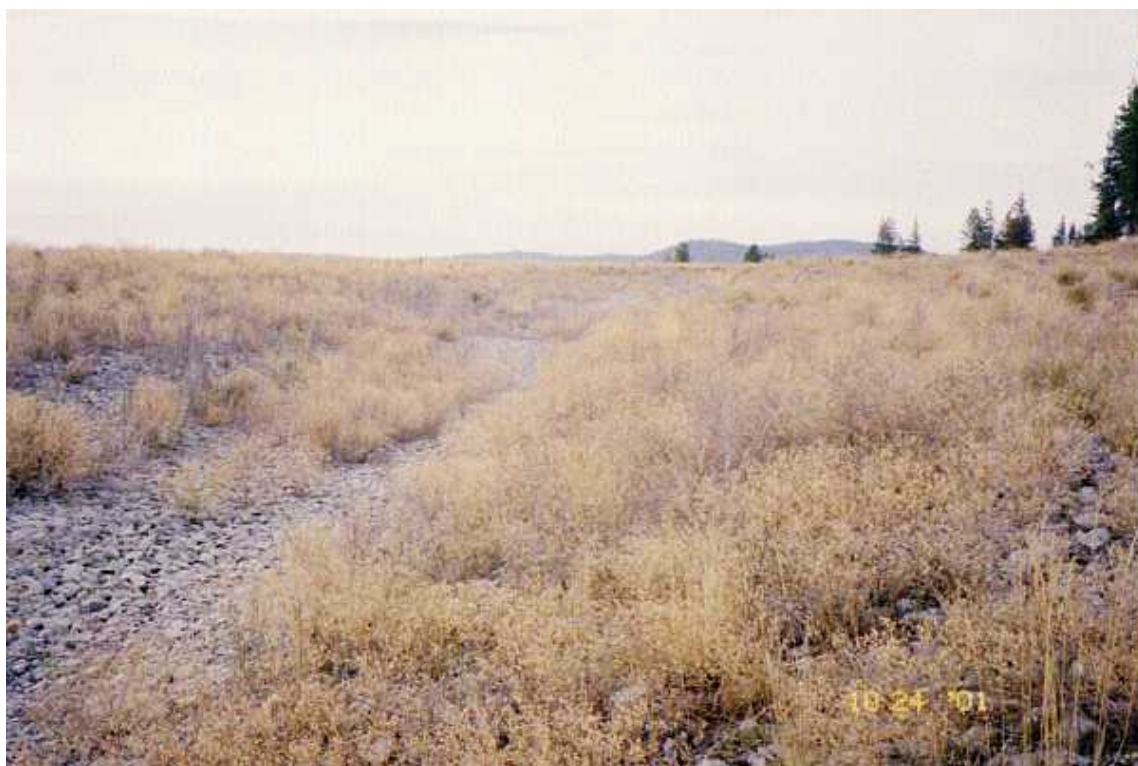
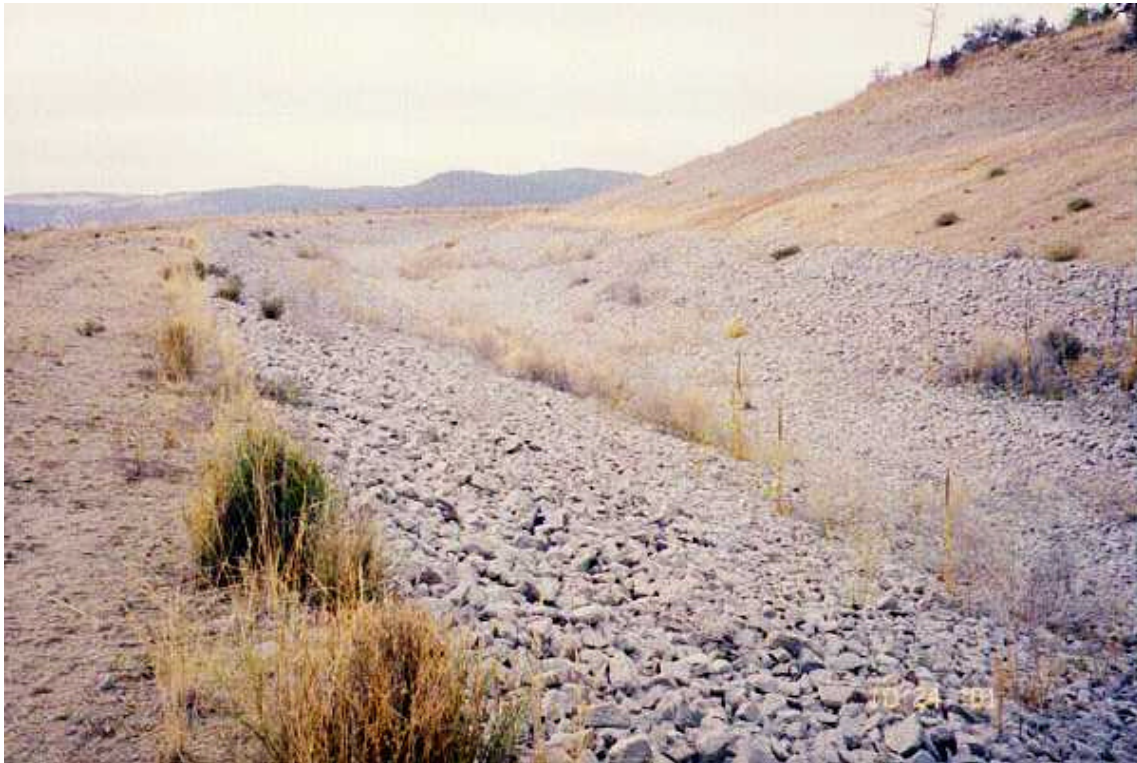
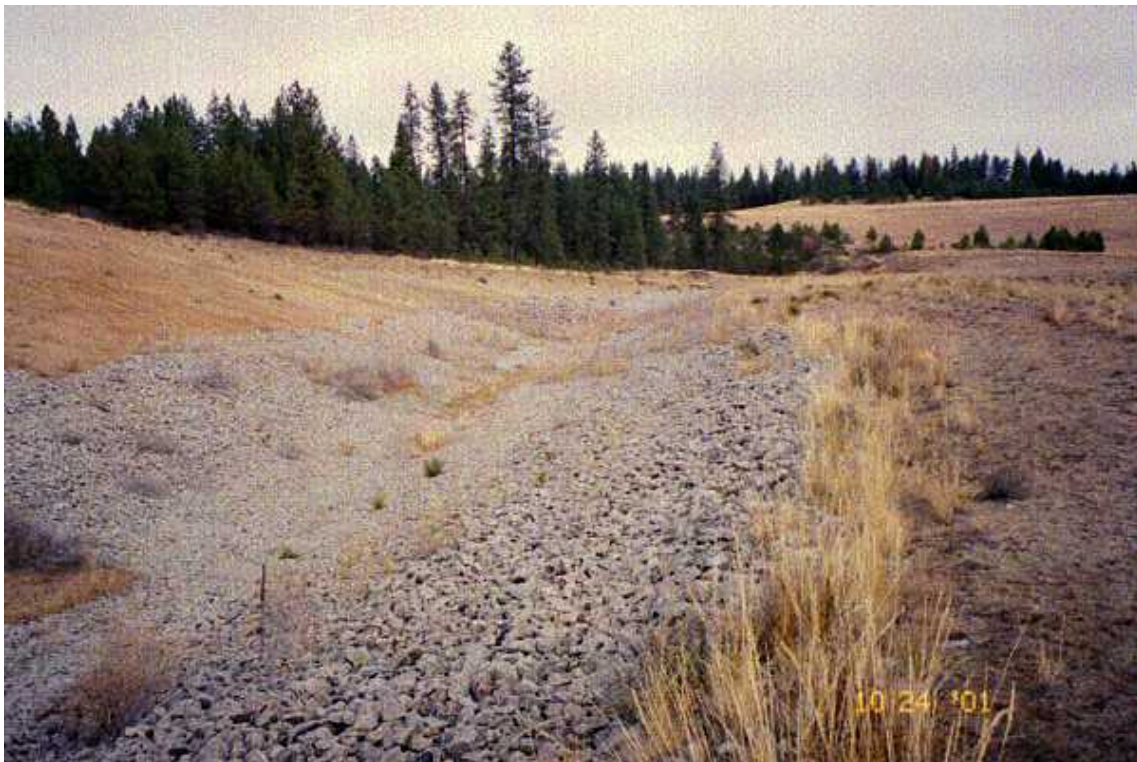
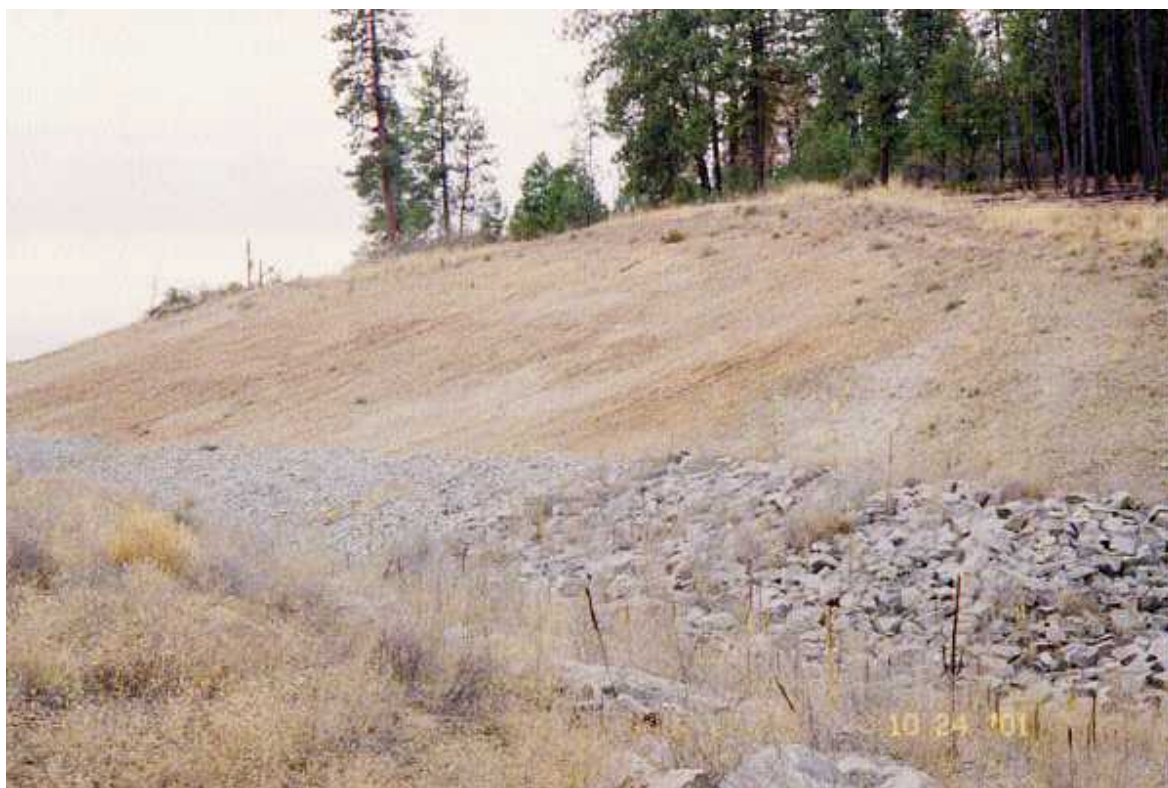
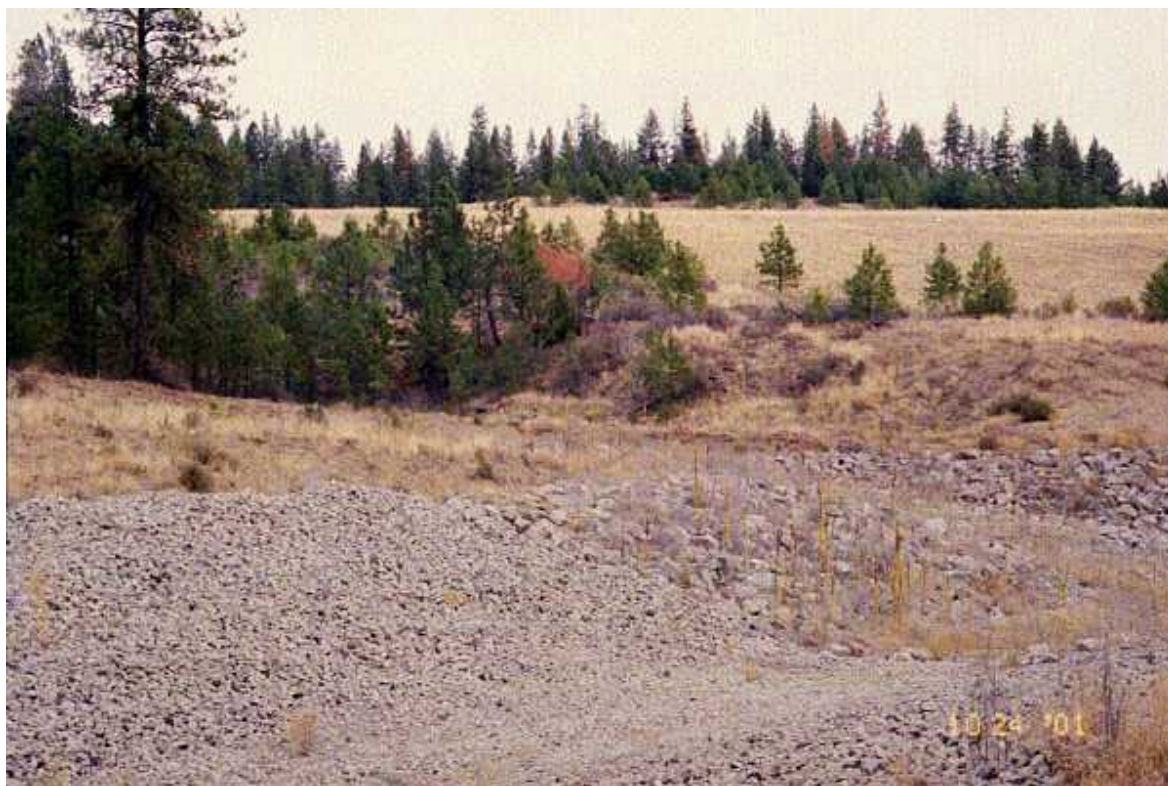
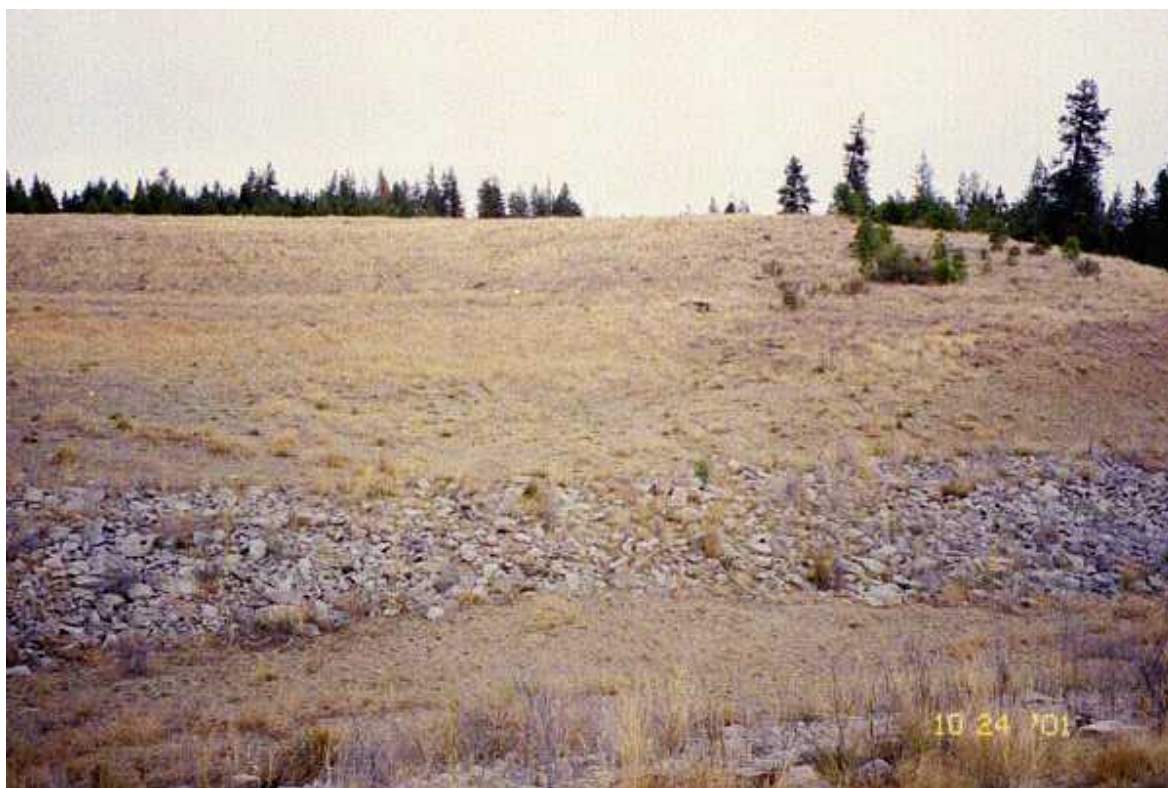
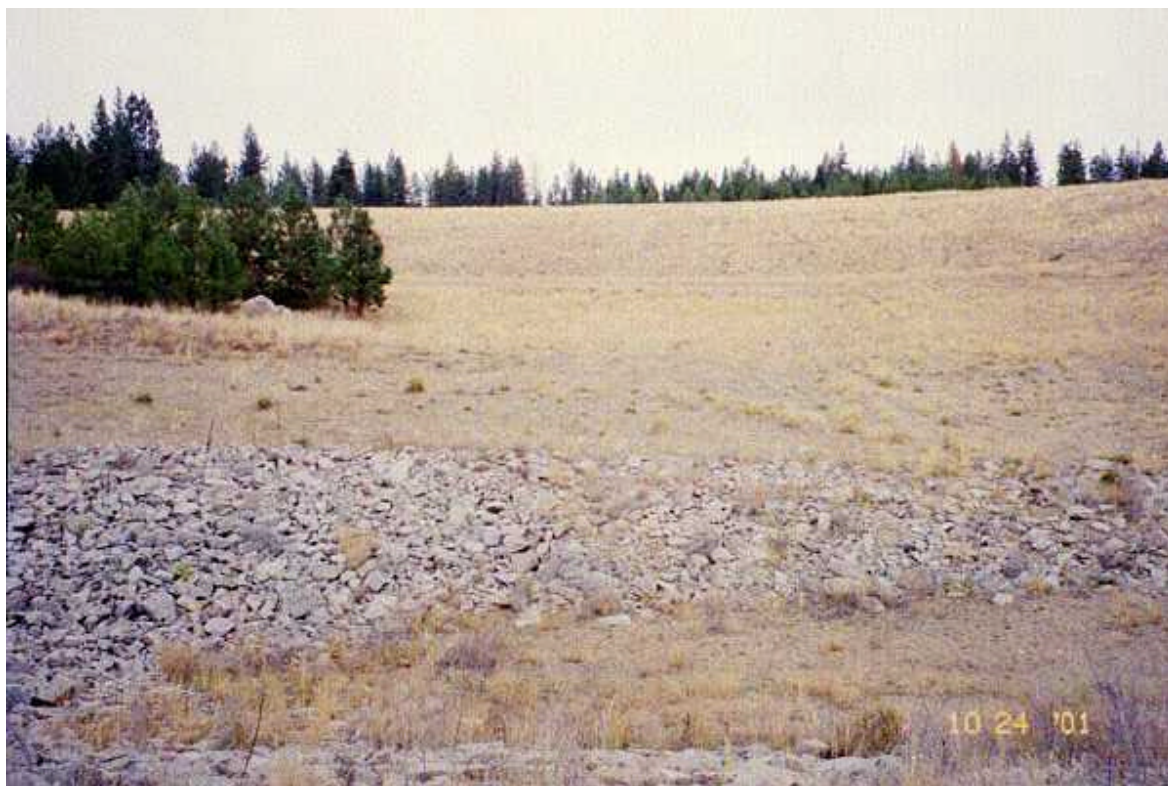
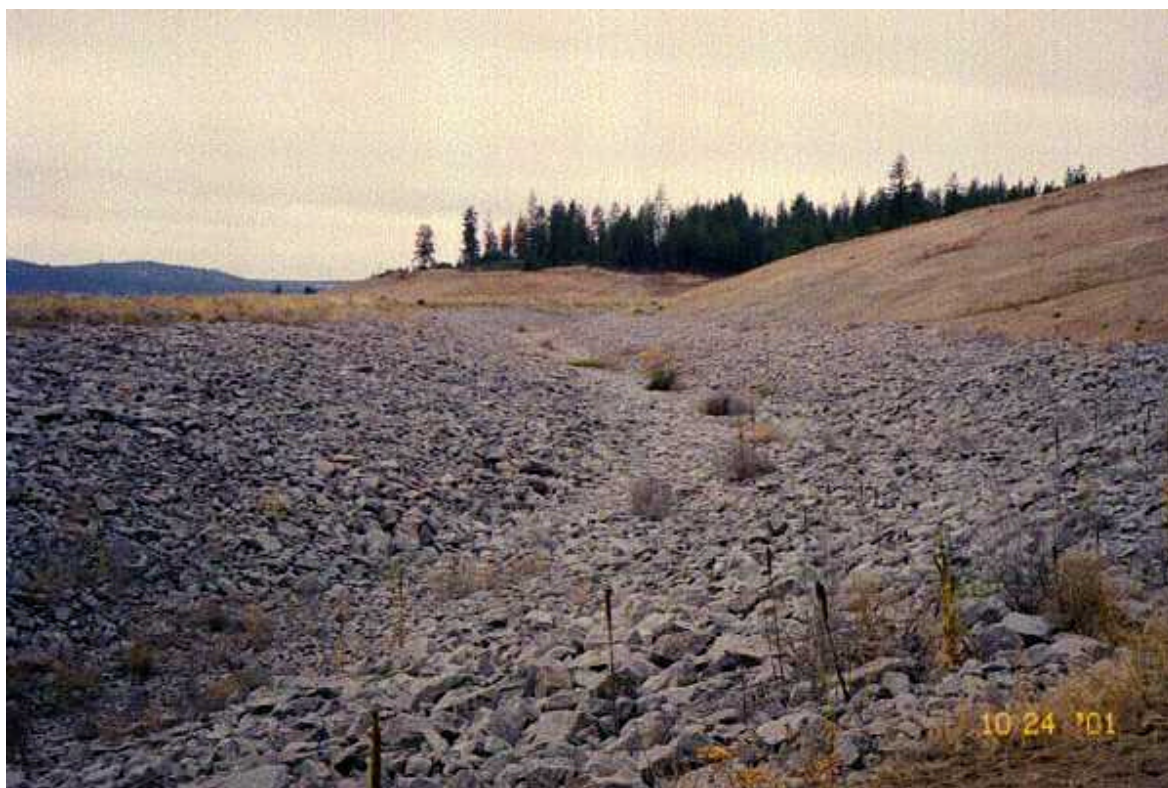
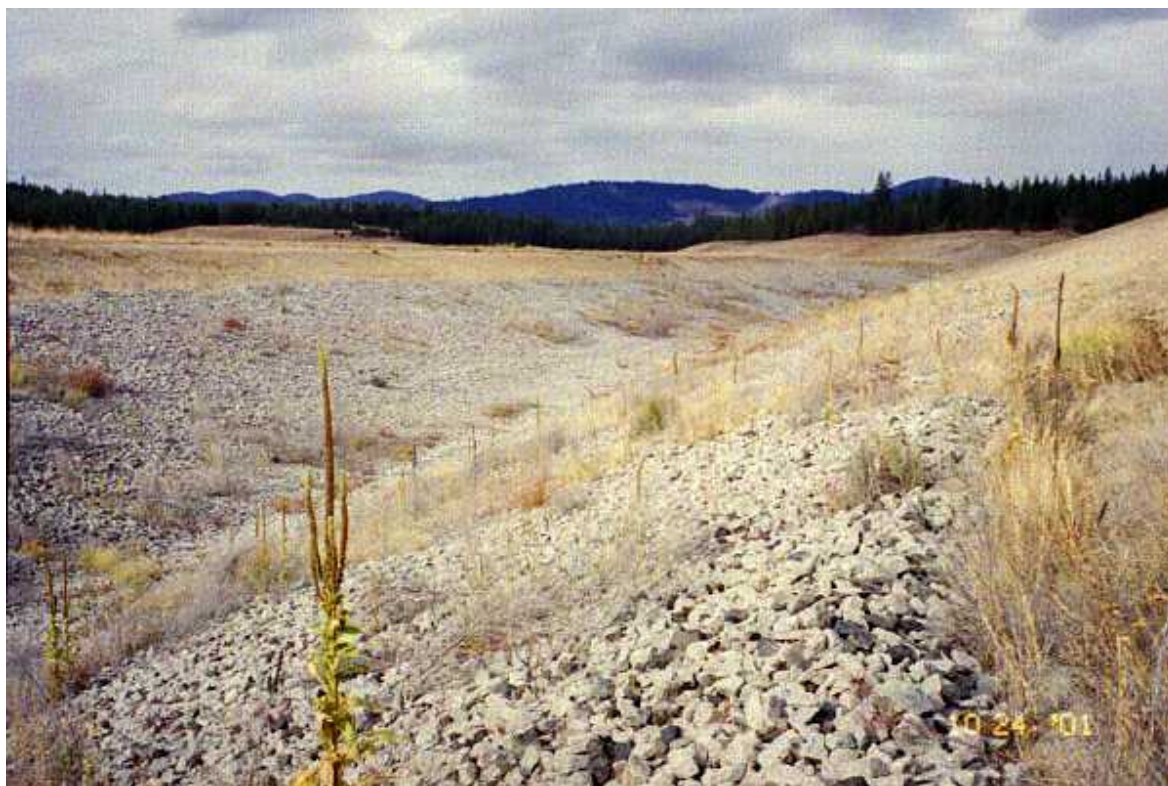
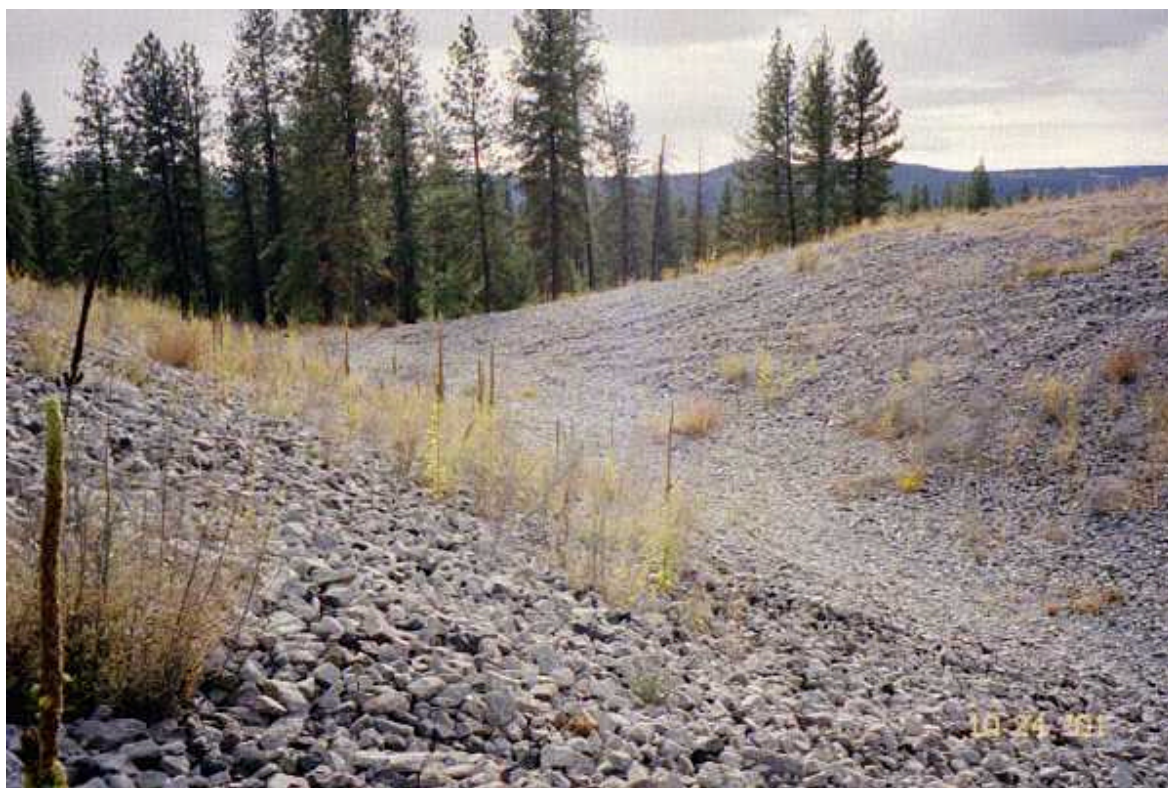
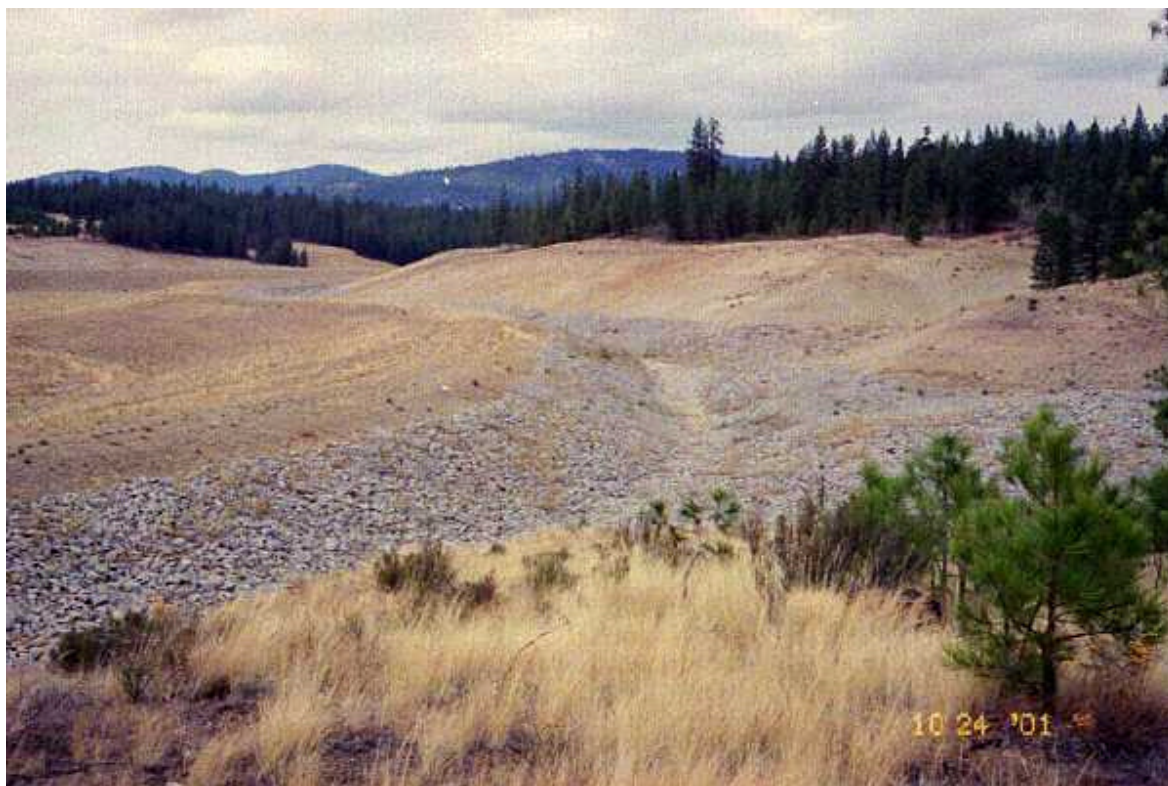
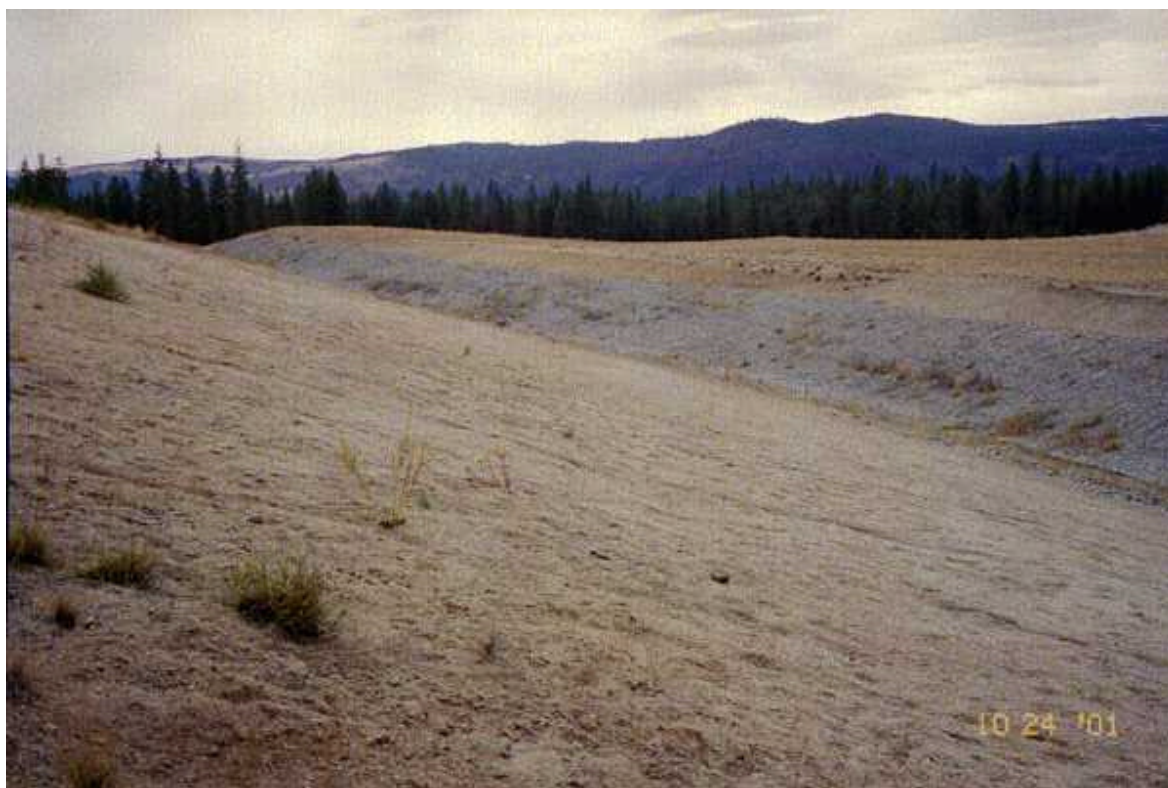
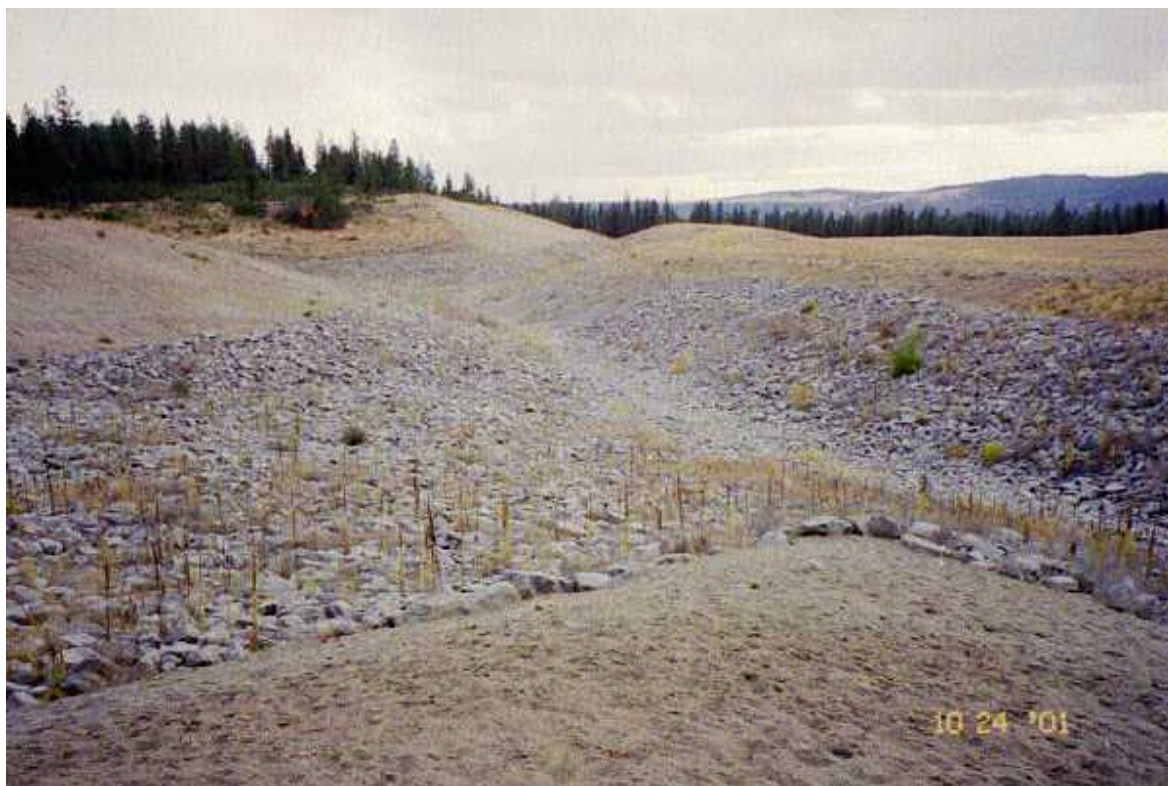
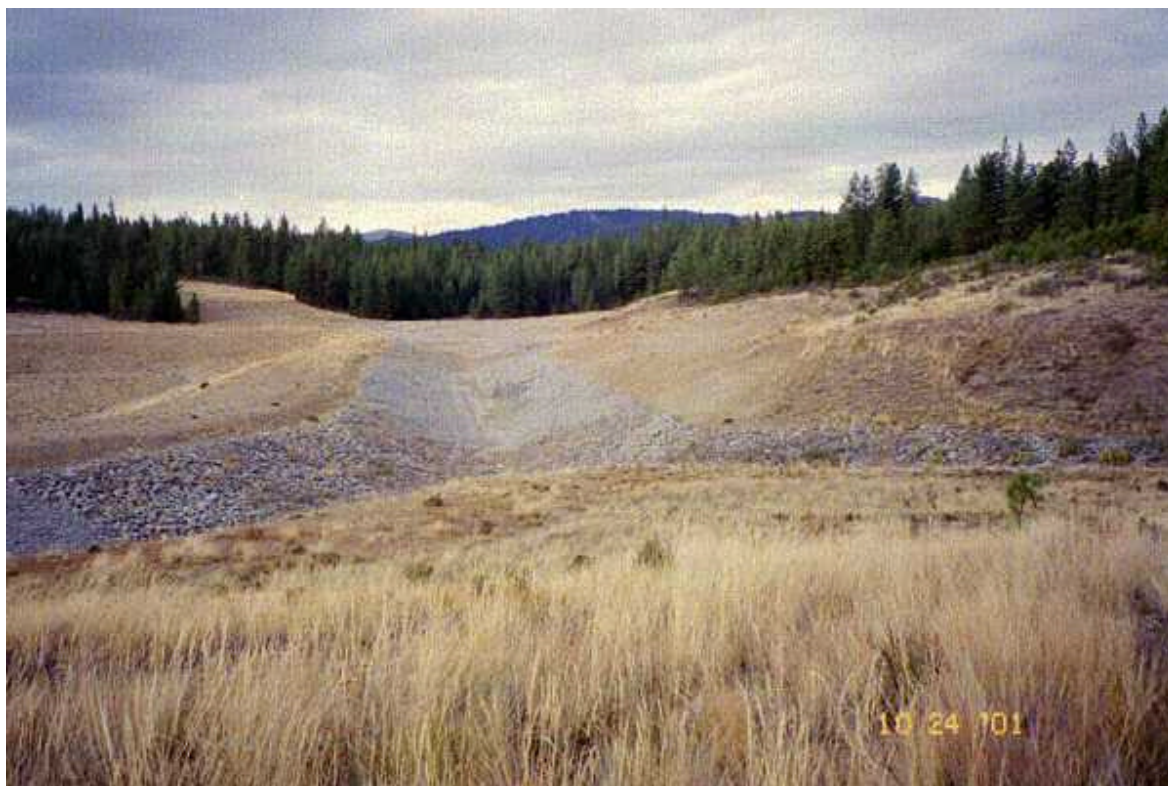
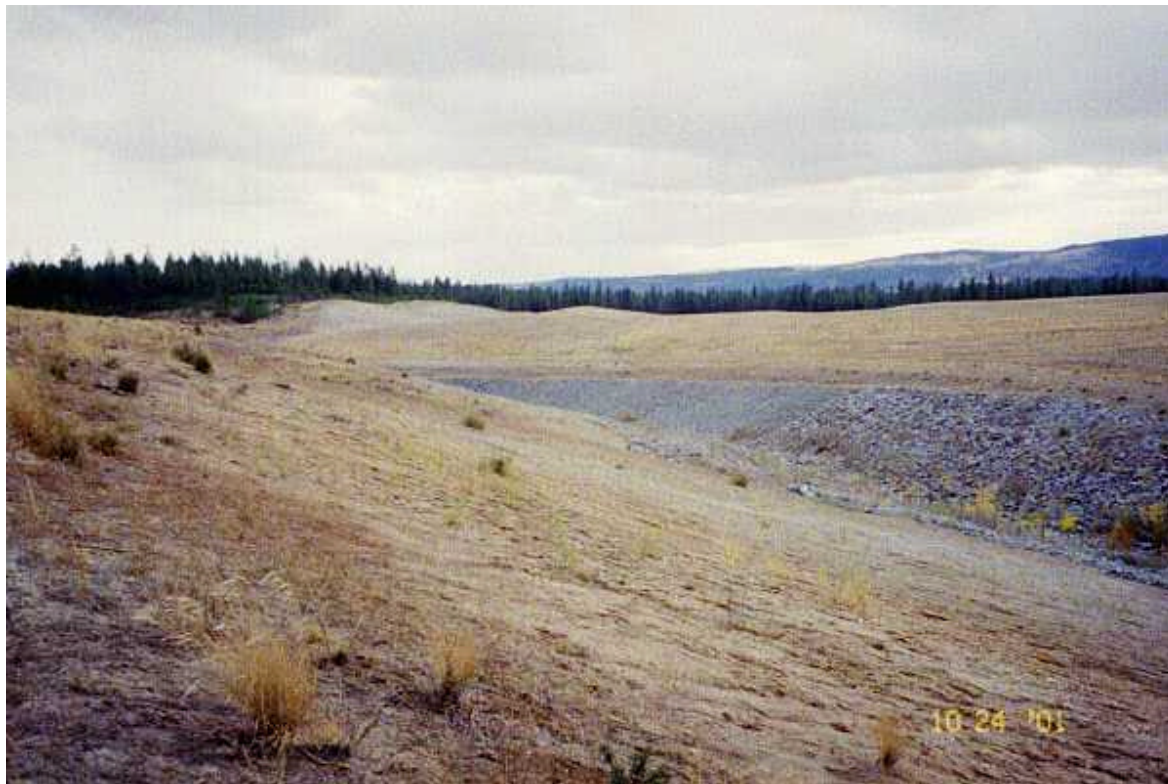
Inspectors walked the length of the diversion channel and took a series of photographs (PL-17 through PL-26). Volunteer plant intrusion within the diversion channel is evident in most of the photographs. This plant intrusion is not expected to interfere with the design function of the diversion channel. Riprap placement and rock condition are the same as observed during earlier orientation inspections. Sediment deposition is evident in places on the west side of the diversion channel (PL-20A and PL-20B). Sediment deposition currently does not interfere with the design function of the diversion channel. The degree of sediment deposition should be noted during future inspections although it is not expected to increase to the degree that it could become a maintenance issue. Standing water was observed in the channel along the east side of the impoundment (PL-24B).

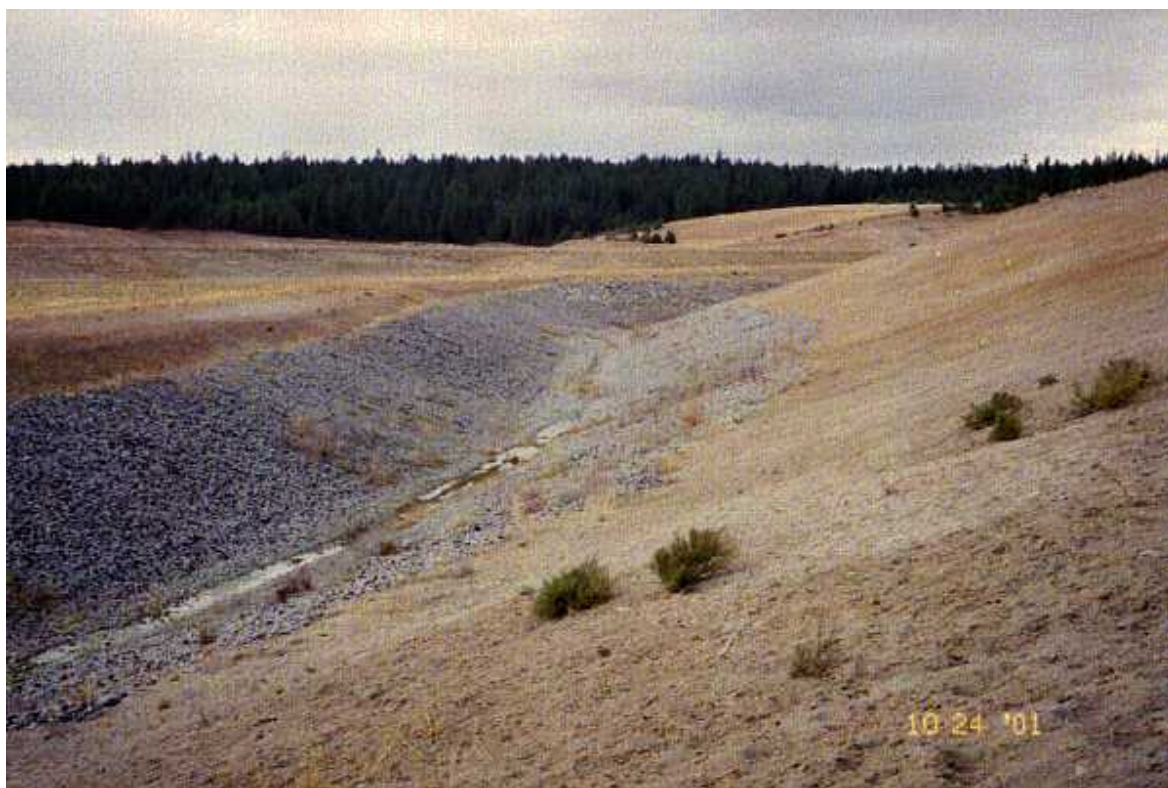
SHE 10/2001. PL-24B. East diversion channel.

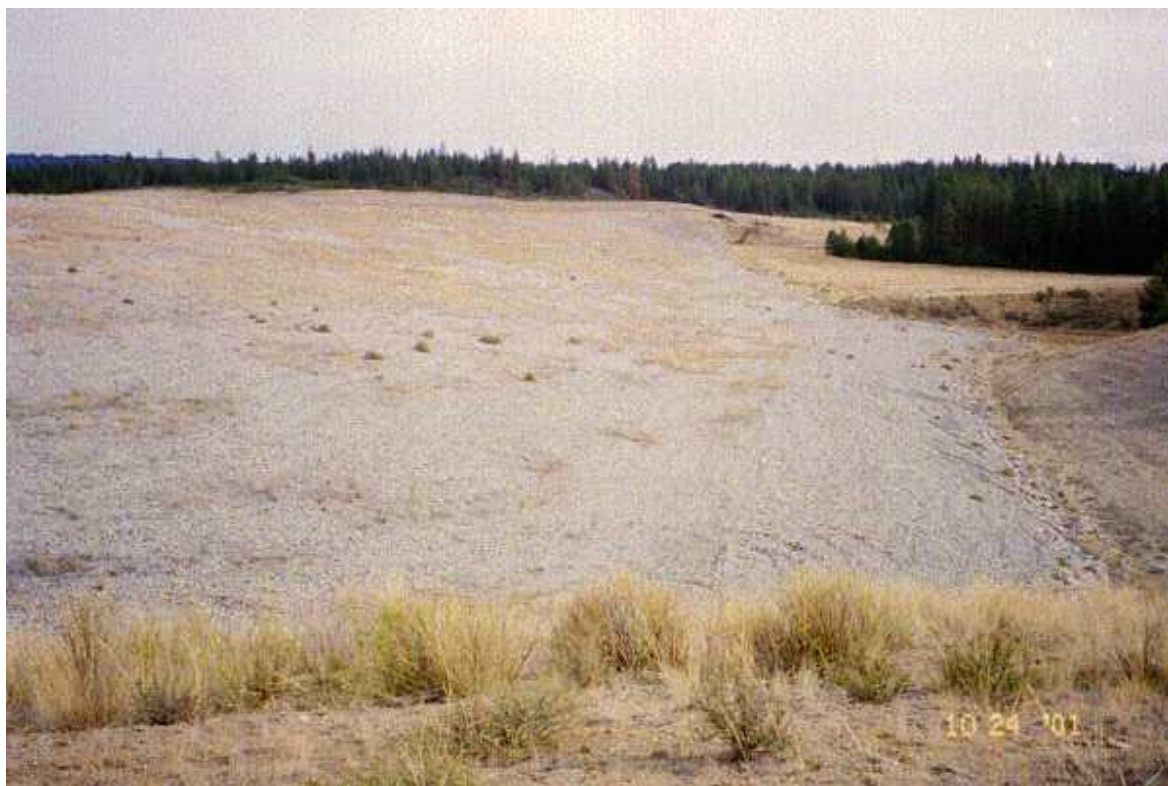
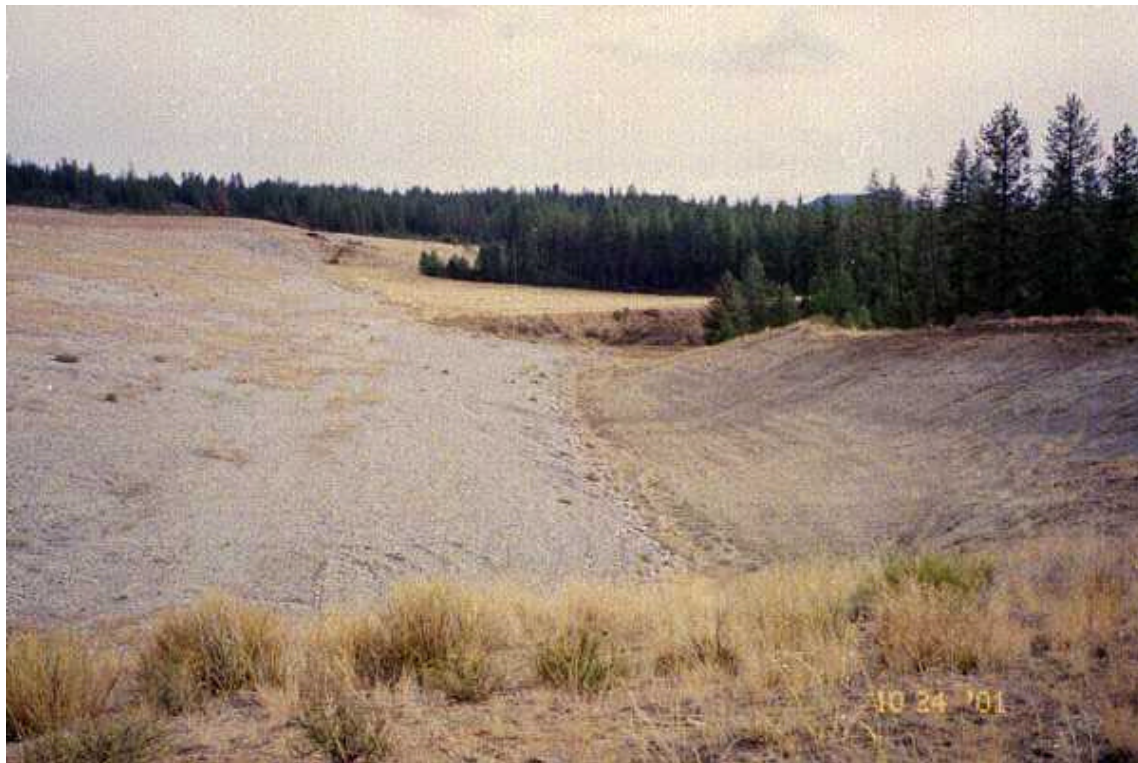
The impoundment dam face was inspected and photographed (PL-27A and PL-27B). The dam was inspected in accordance with the appended Dam Inspection Checklist (see Appendix A). No evidence of seepage, slumping, erosion, or instability was observed. In July 2001 water level measurements were made in the four piezometers installed across the crest of the dam to evaluate dam saturation conditions. Piezometer PZ-2 had 1.95 feet of water in the bottom of the casing. Piezometers PZ-1, PZ-3, and PZ-4 were dry. PZ-2 had 3.05 feet of water upon installation in November 2000. These results demonstrate that the impoundment dam continues to exist in an unsaturated state. Photograph PL-28 shows an undesirable weed species (dalmation toadflax) growing on the dam face.

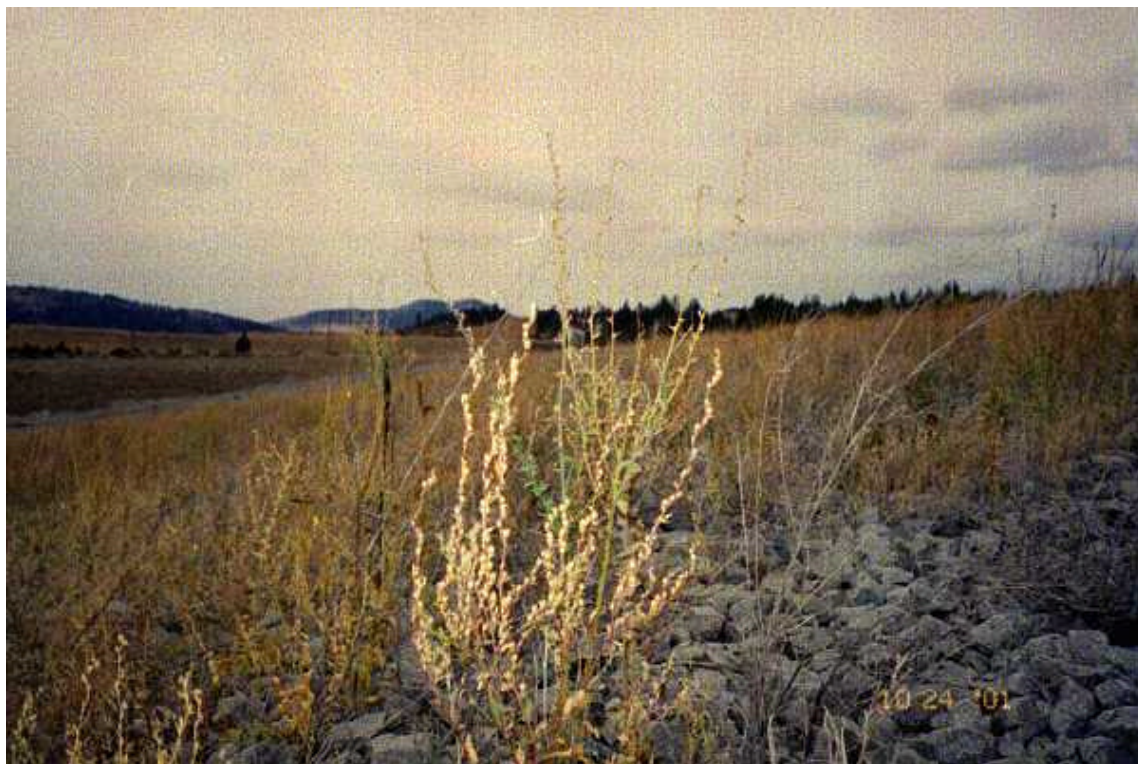
SHE 10/2001. PL-28. Toadflax on dam face.
